900 SOUTH CAROLINA AVENUE SE - ALTERATION

PROJECT DESCRIPTION:

REMOVE AWNING AND BAYS AT FRONT AND ADD TWO NEW DOOR OPENINGS; ADD TWO WINDOW WELLS AT WEST ELEVATION AND LARGER BASEMENT AREAWAY AT REAR; NEW WINDOW OPENINGS AT REAR SECOND STORY; NEW OPENINGS AND CLADDING AT REAR ONE-STORY ADDITION; NEW OPENINGS AT ONE-STORY GARAGE

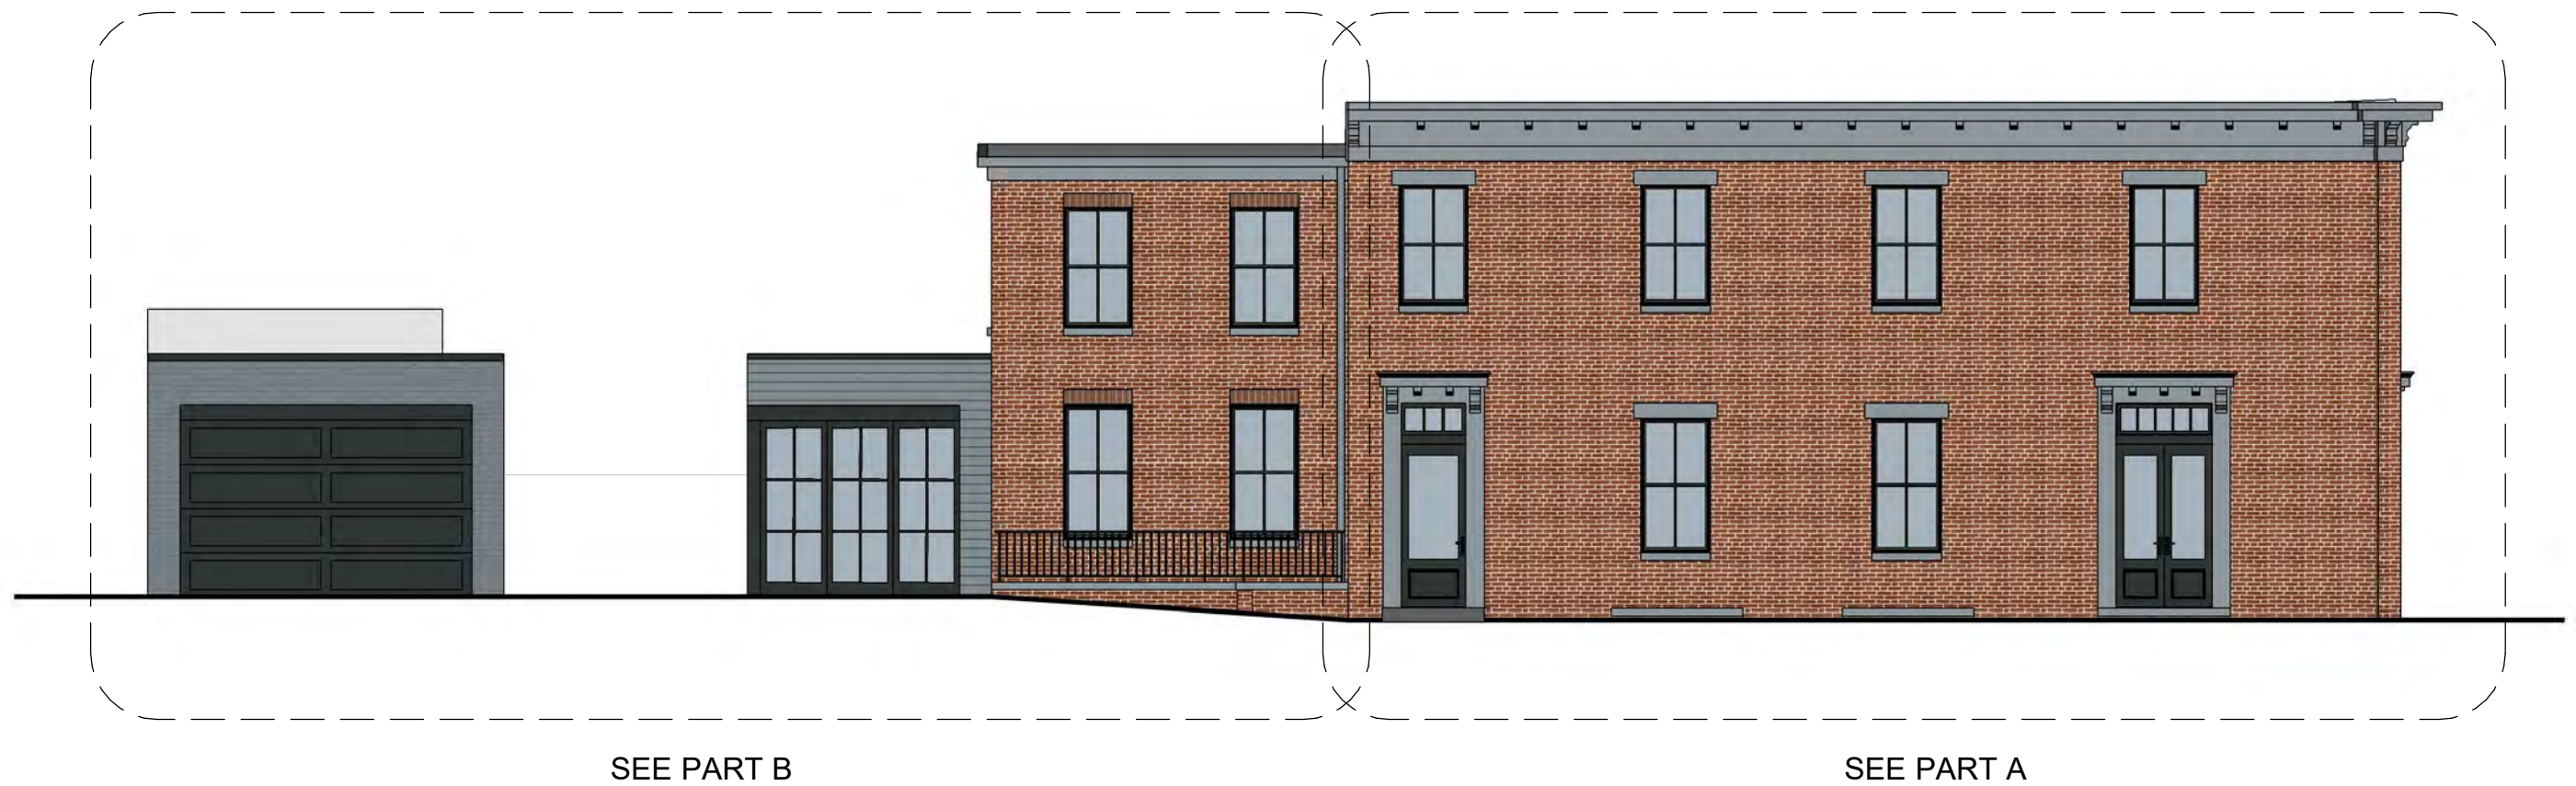
SIDE ELEVATION

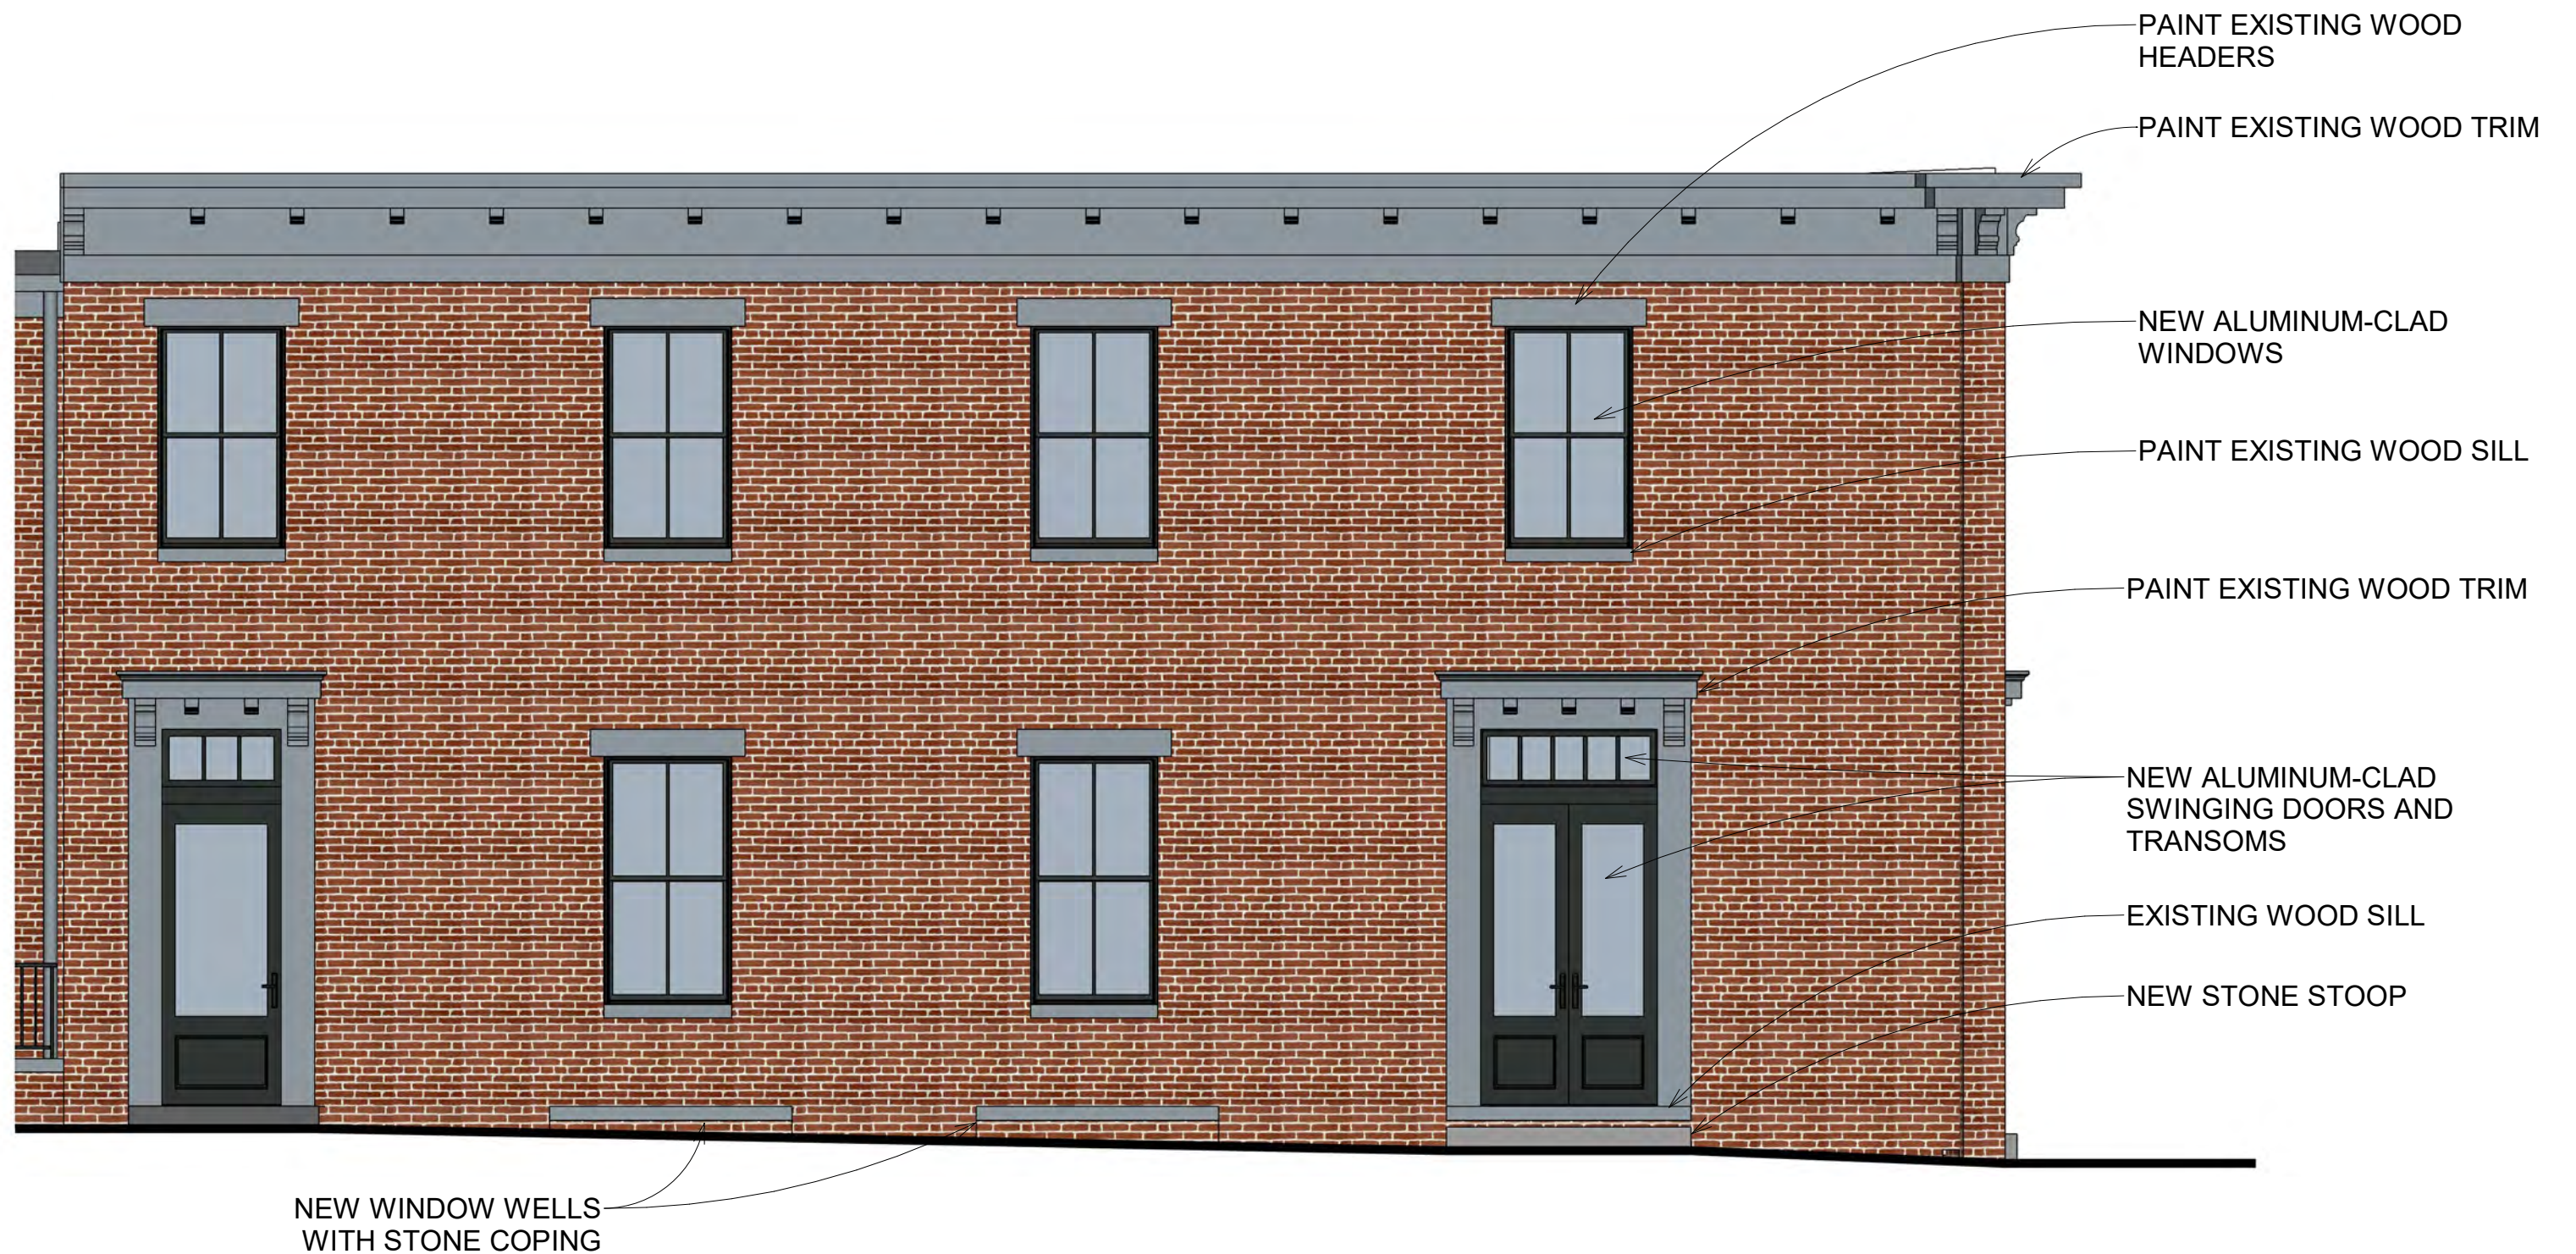
SIDE ELEVATION - PART A

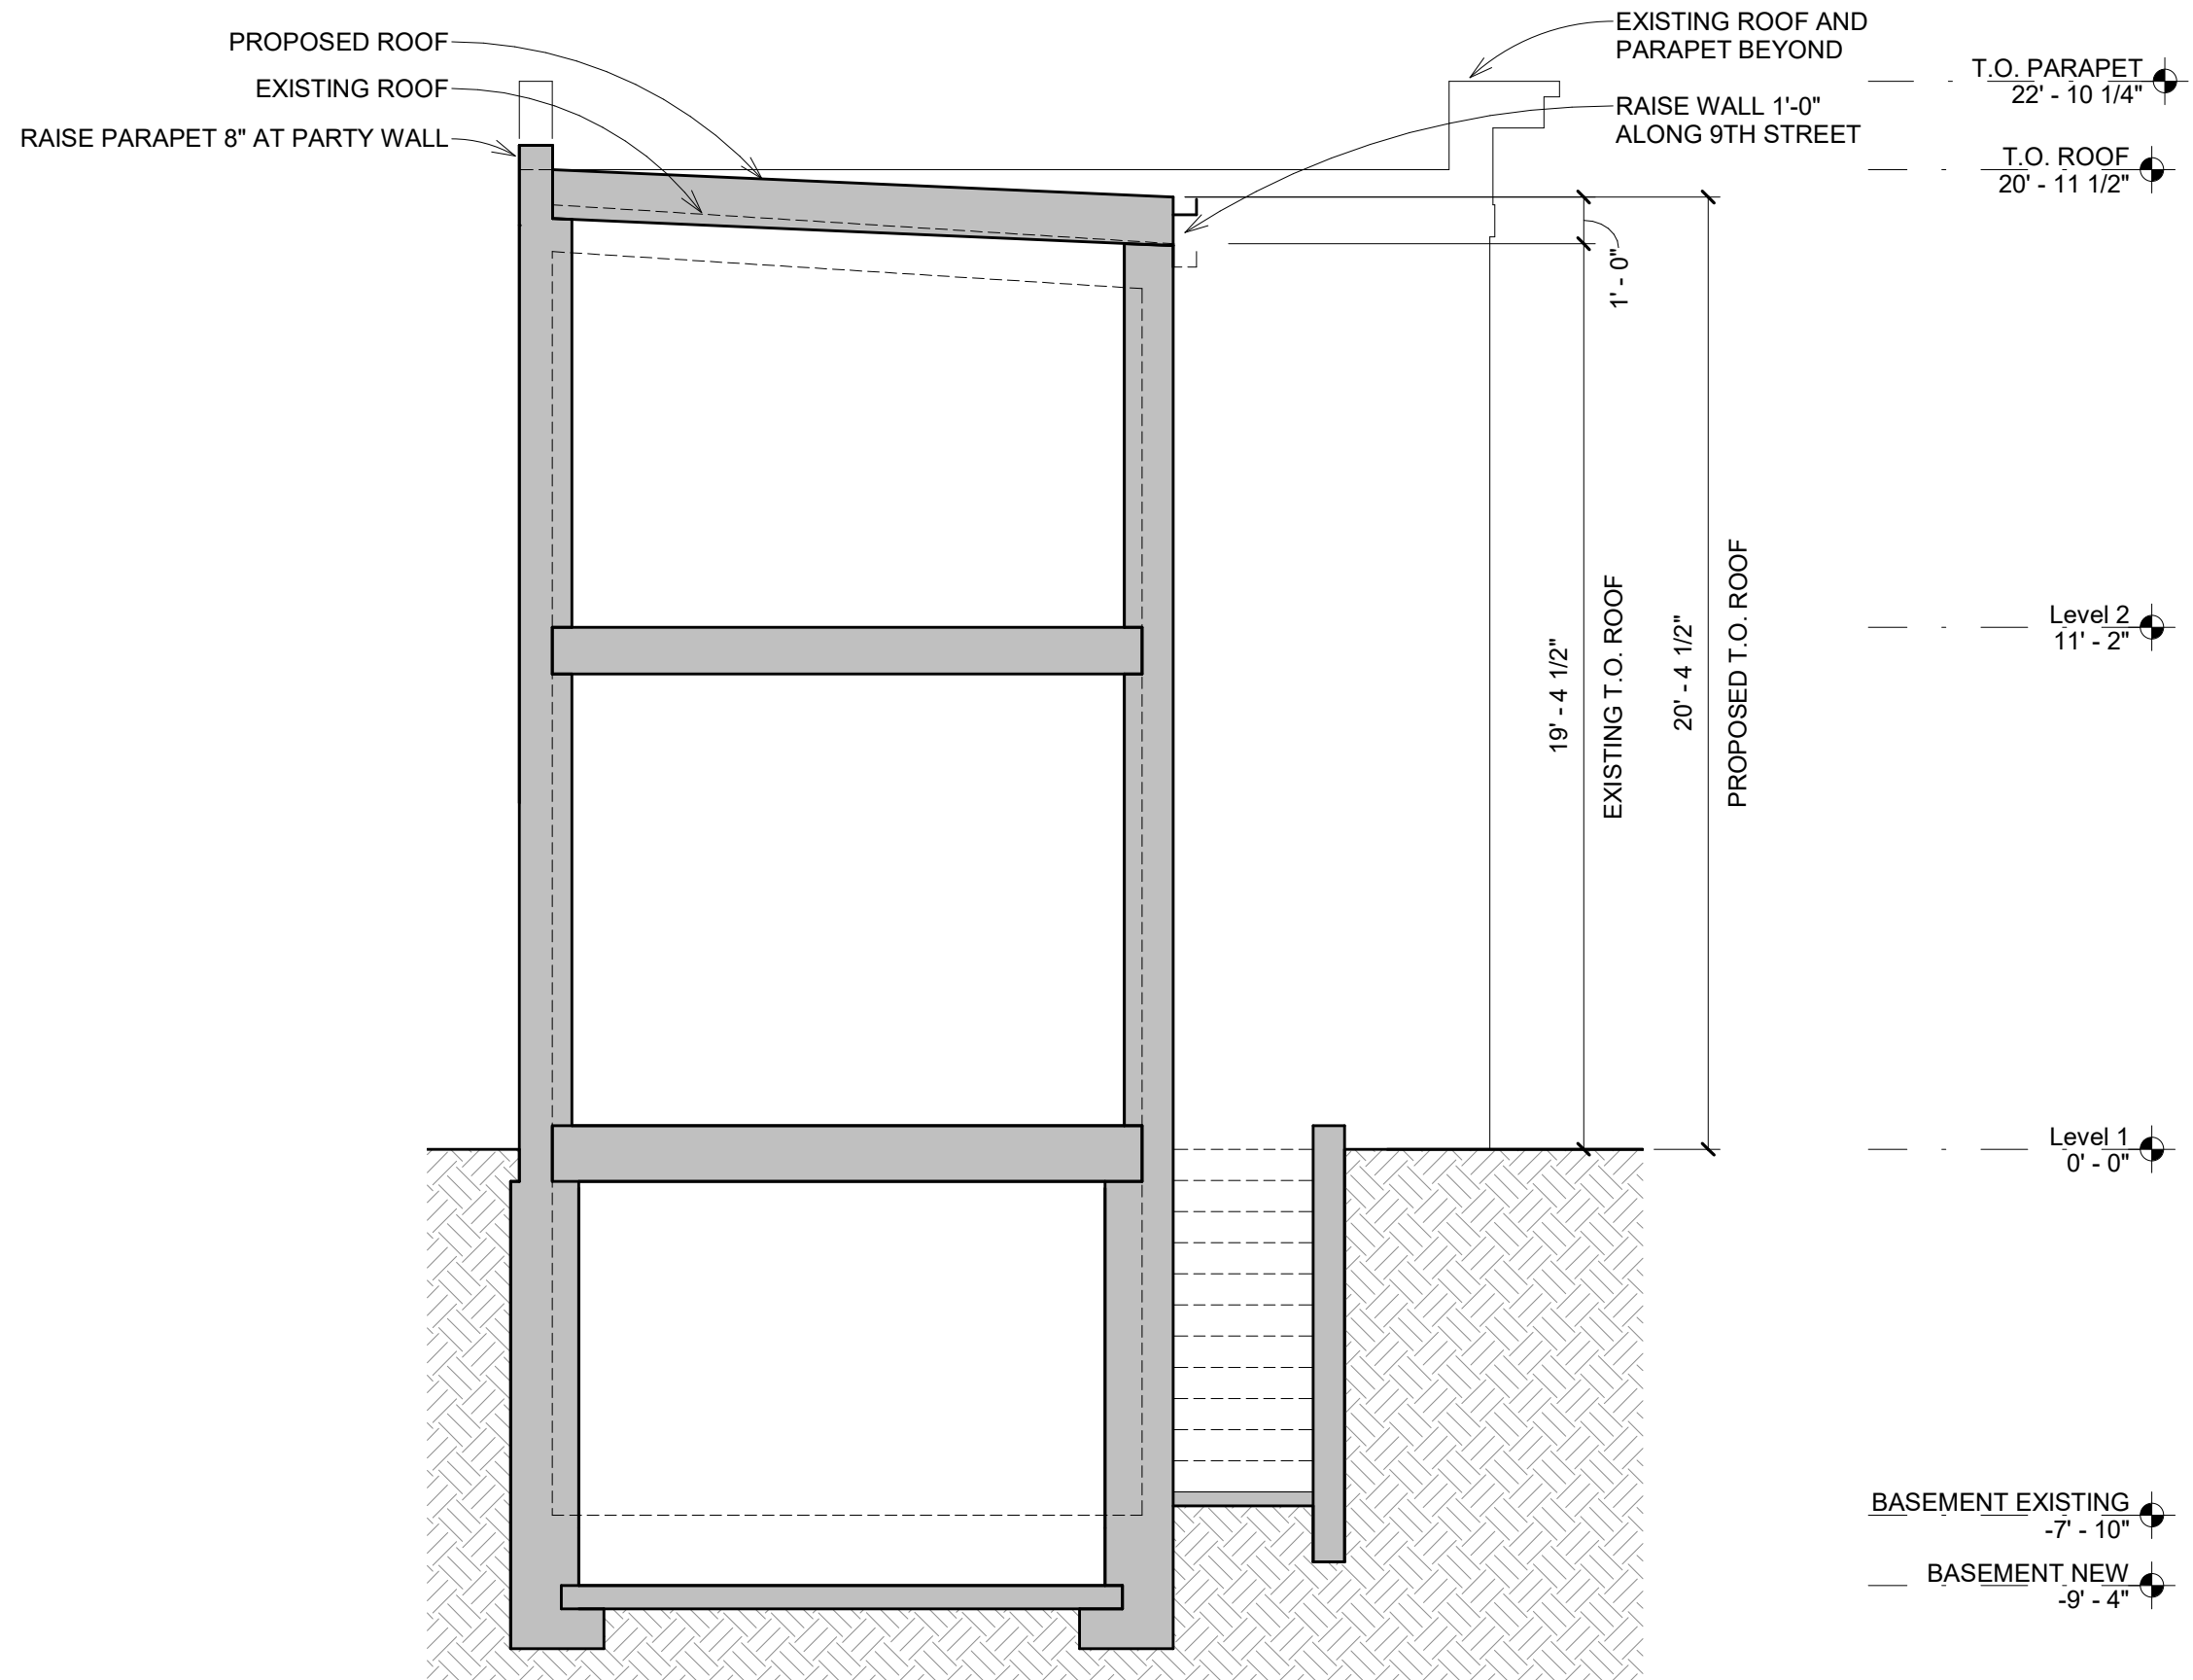
BUILDING SECTION @ REAR 2-STORY

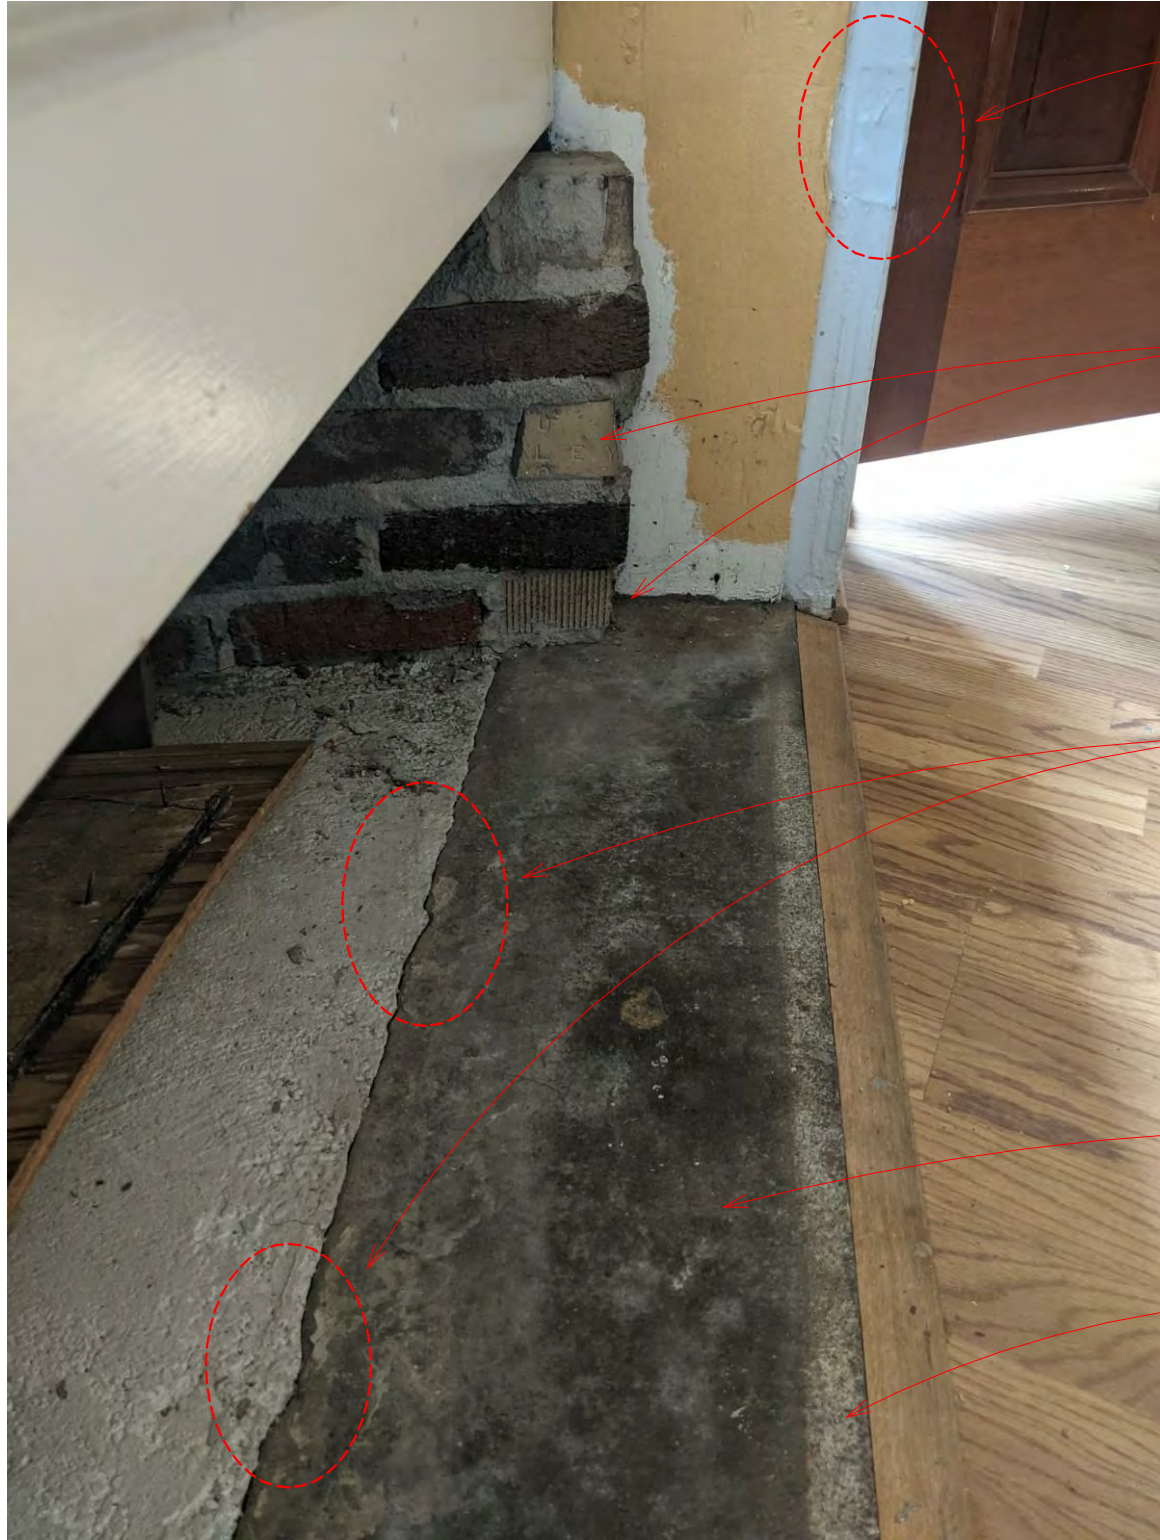
RIGHT BAY
BEHIND WINDOW PROJECTIONS
(LEFT BAY SIMILAR)

EVIDENCE OF HINGE FOR
STOREFRONT DOORS
BEHIND ADDED BAYS

EXISTING HINGE

BLOND BRICK (POPULAR IN
THE 1920's - 1940's)

DISTRESSED EDGE
INDICATES EXTERIOR
WEATHERING AND USE AS
A DOORWAY

SIMILAR WEATHERING
HERE

DISCOLORATION OF
STONE SILL CAUSED BY
EXPOSURE TO EXTERIOR
WEATHER & POLLUTION

LIGHTER GRANITE WHERE
DOOR THRESHOLD LIKELY
COVERED THE STONE

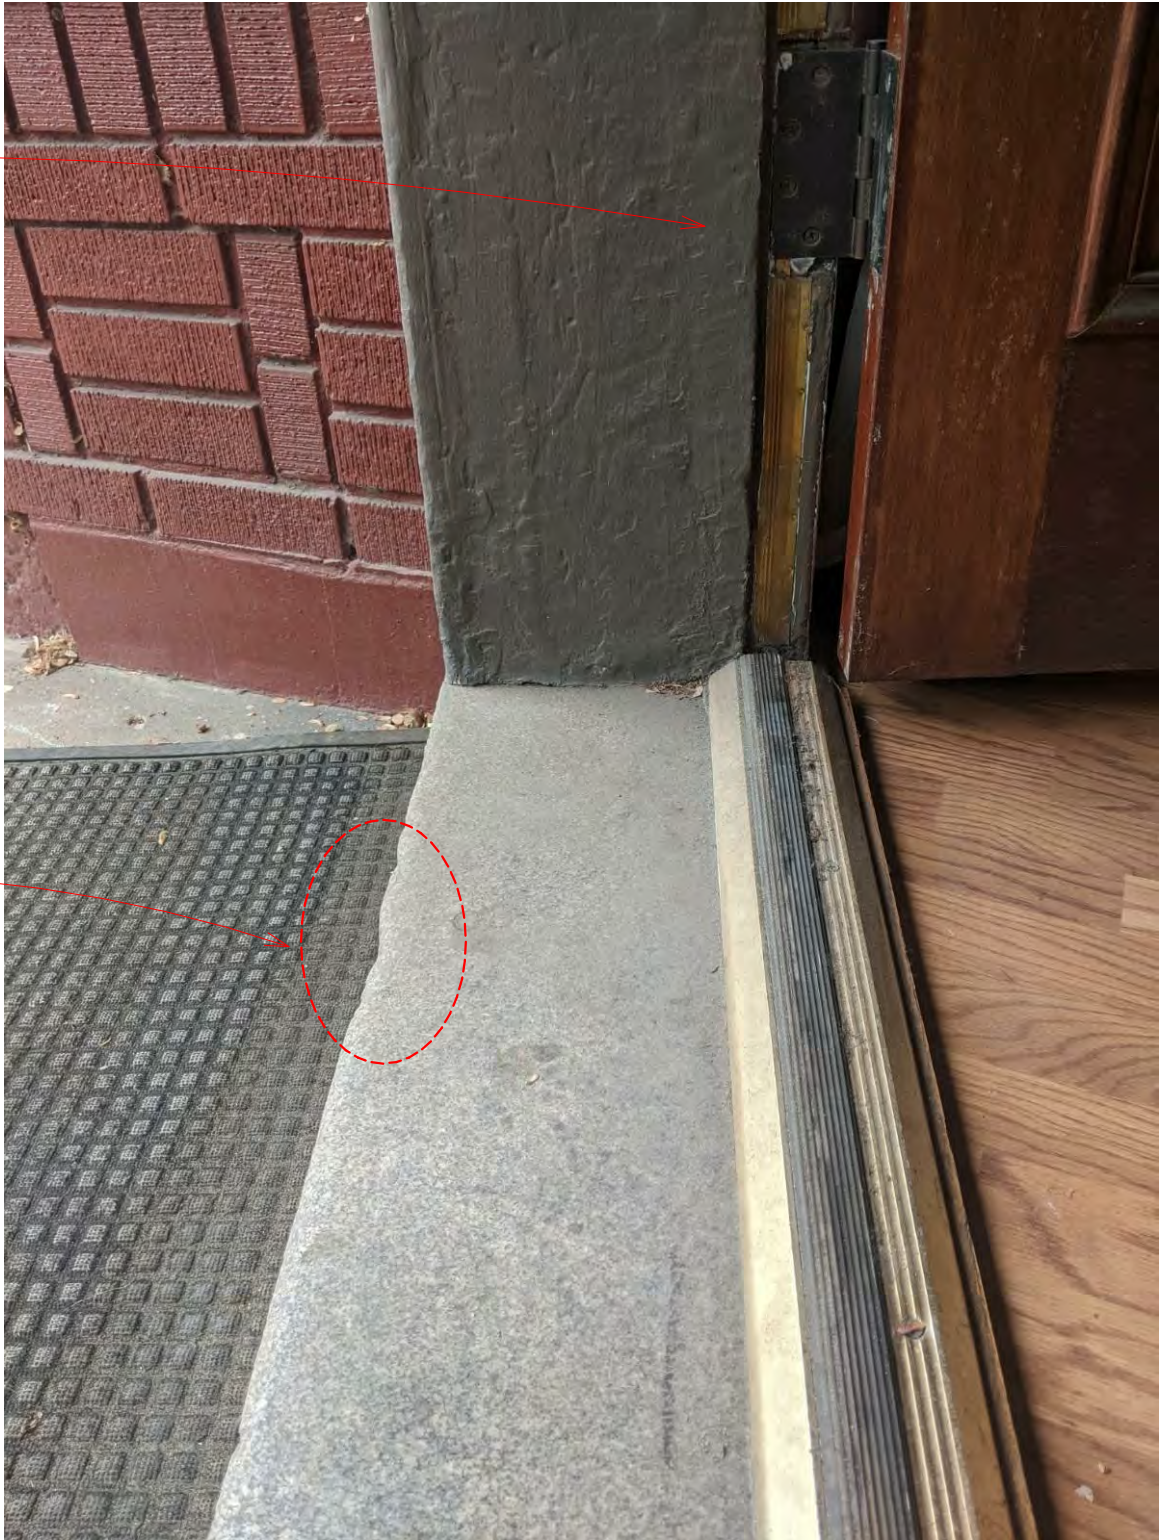
CENTER BAY
WHERE CURRENT DOORWAY IS

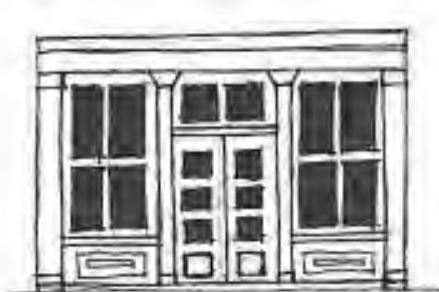
Early to Mid 1800's
Post and Beam Frame
Divided Display Windows
Simple Decoration

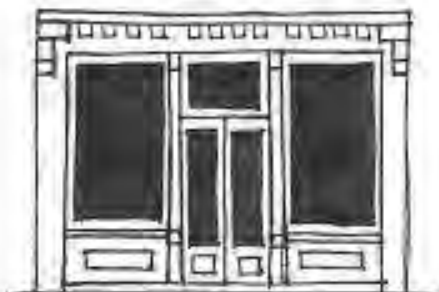
Mid to Late 1800's
Boldly Decorated Cornice
Cast Iron Columns
Large Display Windows

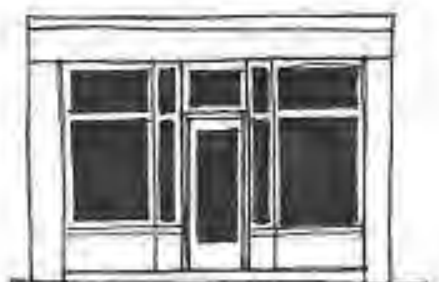
Late 1800's to Early 1900
Simple Cornice
Transom Windows
Recessed Entrance

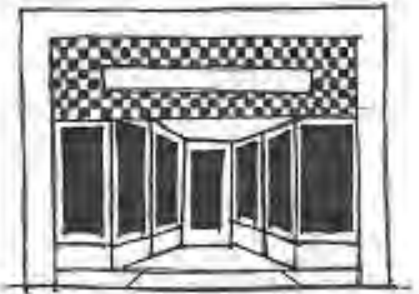
Early 1900's to 1930's
Metal Window Frames
Structural Glass
Recessed Entrance

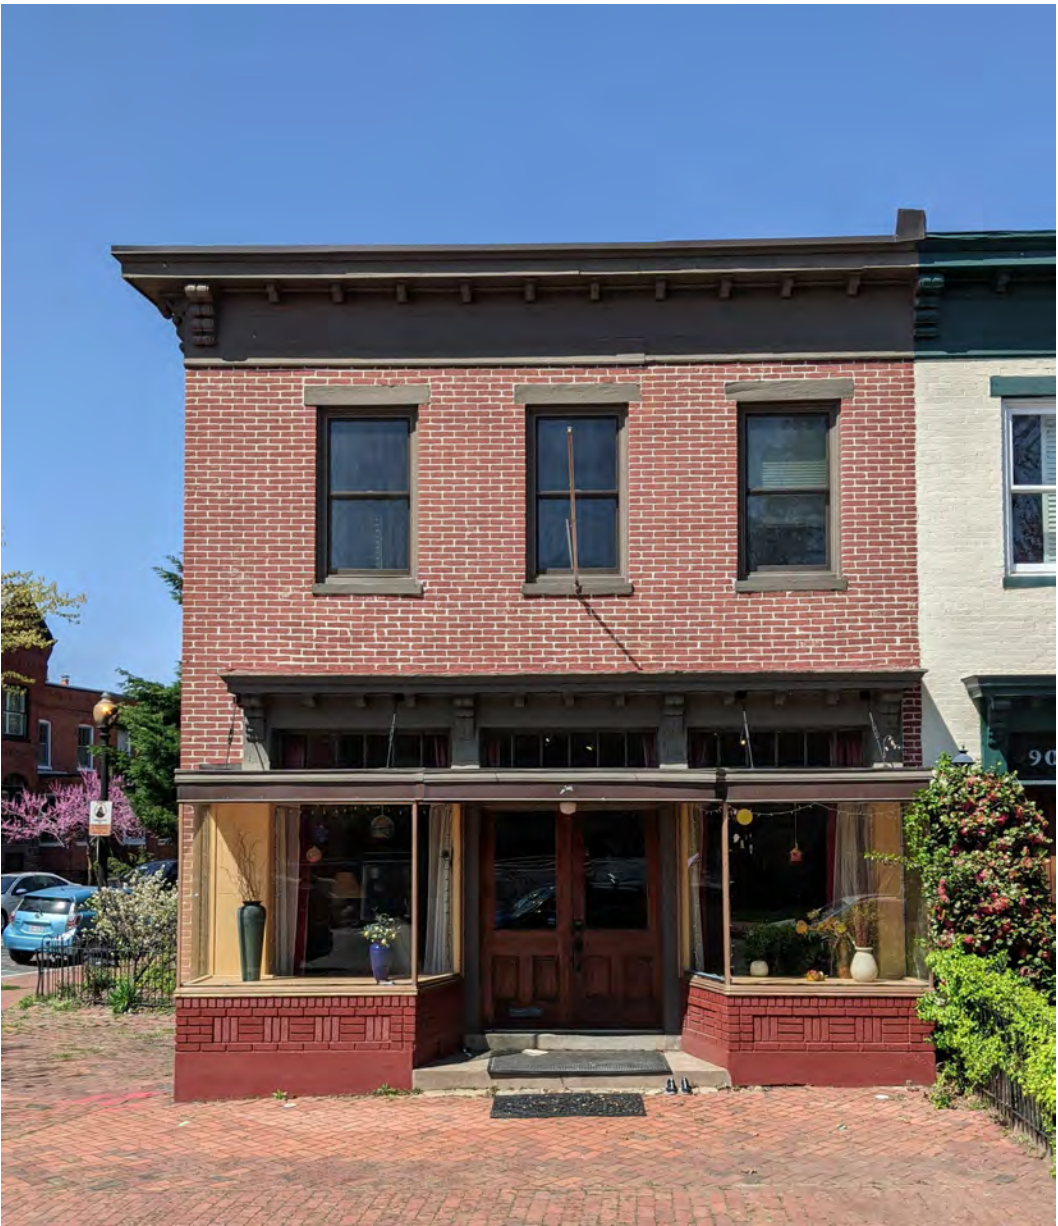
- IT'S A PURPOSE-BUILT CORNER STORE, BUILT IN 1870 FOR A FIRST-FLOOR GROCER AND SECOND-FLOOR RESIDENCE
- POST AND BEAM CONSTRUCTION WITH BOLDLY DECORATED CORNICE
- EXCELLENT EXAMPLE OF PLANAR STOREFRONTS THAT WERE CHARACTERISTIC OF THAT TIME
- EVIDENCE INDICATES THAT EACH OF THE 3 FRONT OPENINGS ORIGINALLY HAD PAIRS OF DOORS
- THE STOREFRONT WRAPS THE CORNER WITH AN ADDITIONAL PAIR OF DOORS FACING 9TH STREET
- THE ORIGINAL 1870 STOREFRONT IS LARGELY INTACT (BEHIND AND ABOVE THE BAY WINDOWS)

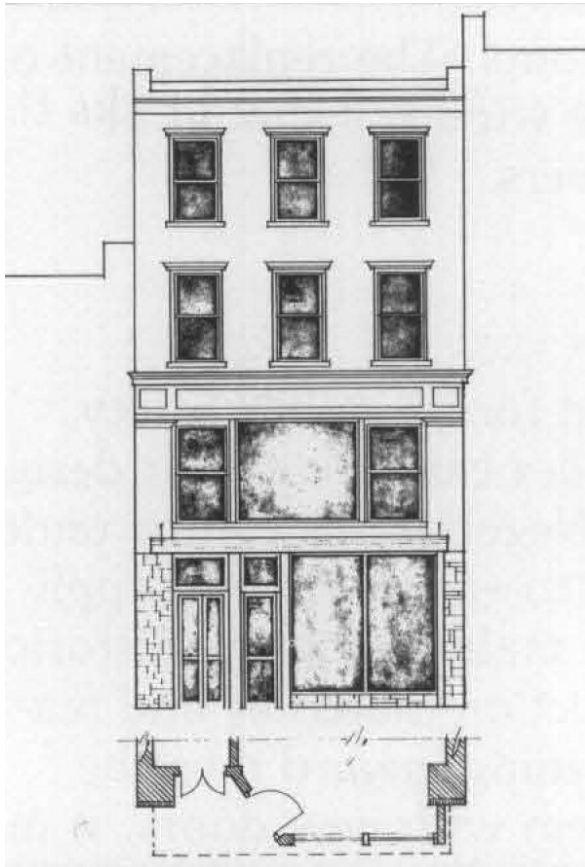
"THIS EXISTING STOREFRONT, ADDED IN THE 1950'S TO A LATE 19TH CENTURY BRICK BUILDING, EXTENDS BEYOND THE PLANE OF THE FACADE; IT DOES NOT CONTRIBUTE TO THE ARCHITECTURAL AND HISTORIC CHARACTER OF THE BUILDING."

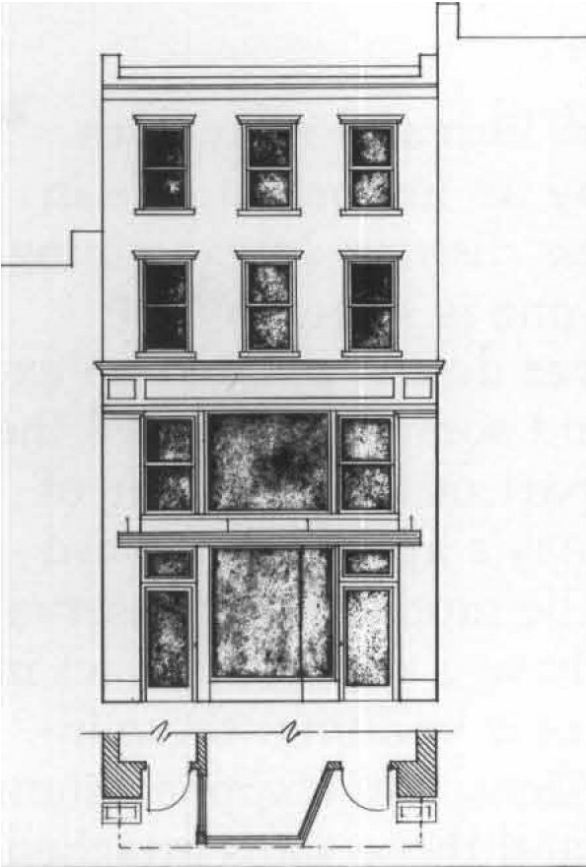
"THIS REPLACEMENT DESIGN RETAINS THE 1950'S PROJECTING CANOPY, BUT SYMMETRICAL PLACEMENT OF THE DOORS RELATES WELL TO THE SECOND FLOOR WINDOWS ABOVE; THIS CONTEMPORARY DESIGN IS COMPATABLE WITH THE SCALE AND CHARACTER OF THE BUILDING."

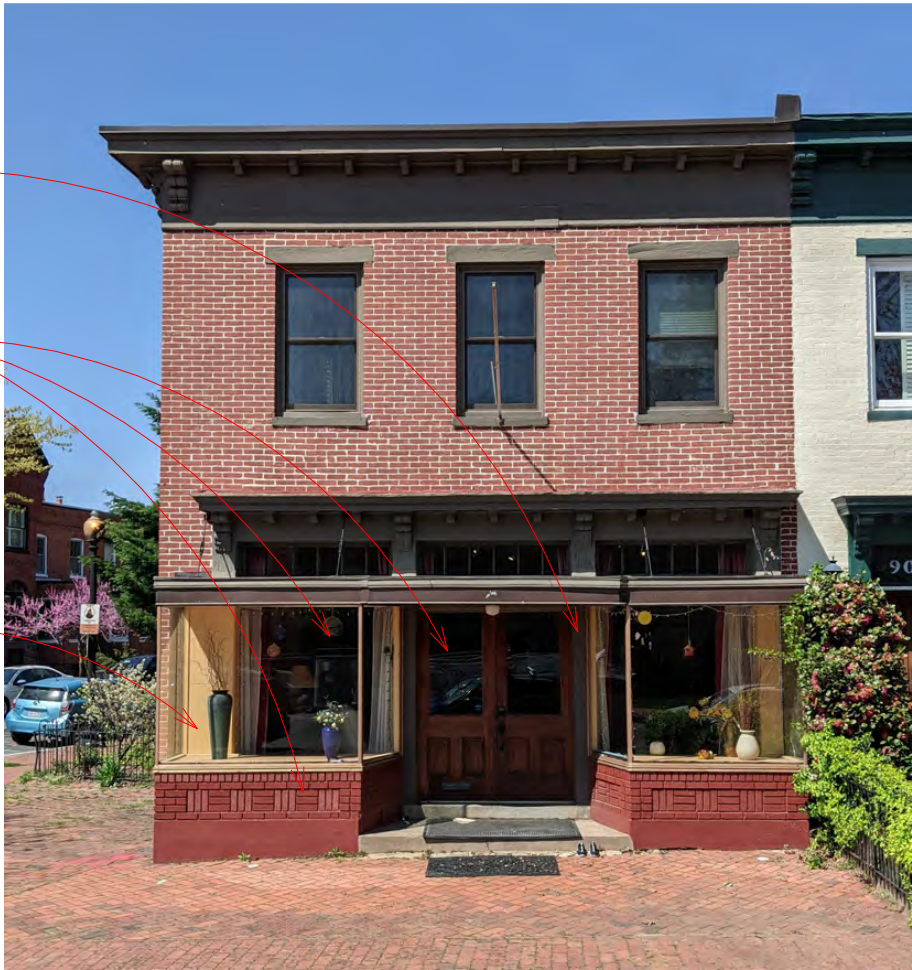
CURRENT FRONT FACADE

PLANAR POST AN BEAM
FACADE BEYOND IS IN
GOOD CONDITION AND
SHOULD BE RESTORED

BRICK BULKHEADS,
PROJECTING BAYS, ART
DECO DETAILING, AND
RECESSED ENTRANCE
DETRACT FROM THE
ARCHITECTURAL AND
HISTORIC CHARACTER

BAYS ARE NOT
SYMMETRIC AND LEFT
BAY DOES NOT ALIGN
WITH THE ORIGINAL
OPENING BEHIND

- STOREFRONTS FROM THE TIME THE ORIGINAL STRUCTURE WAS BUILT WERE TYPICALLY PLANAR WITH LARGE DISPLAY WINDOWS RAISED OFF THE GROUND WITH A BULKHEAD.
- THE BAYS WERE ADDED AT A LATER DATE, EXTEND BEYOND THE PLANE OF THE FACADE, AND DO NOT ALIGN WITH ORIGINAL OPENINGS BEHIND OR THE WINDOWS ABOVE.
- THE DESIGN, DETAILING, CHOICE OF MATERIALS, AND GEOMETRY OF THE BAY ADDITION ARE IN CONFLICT WITH THE ORIGINAL HISTORIC CHARACTER OF THE BUILDING.
- THE ORIGINAL PIERS AND OPENINGS ARE IN GOOD SHAPE AND SHOULD BE RESTORED.
- THE PROPOSED DESIGN WILL RESTORE THE HISTORIC PLANAR RELATIONSHIP OF STOREFRONT TO FACADE.
